Cheshire Reserves Newsletter.

Rostherne May 2021

Rostherne Mere NNR wetland enhancement project March 2021

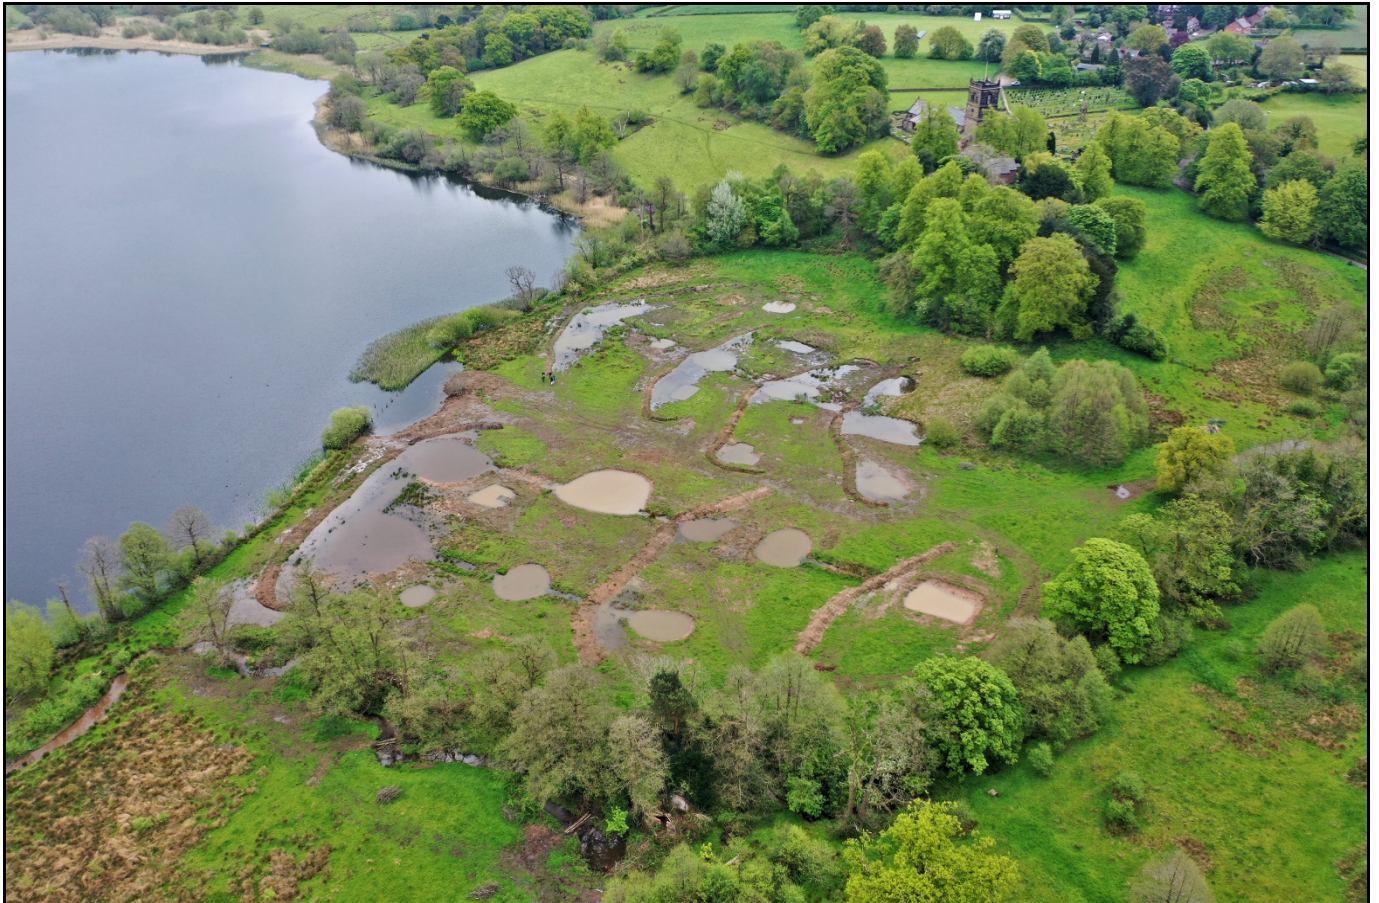
Dolls Meadow looking in a south easterly direction where most of the enhancement work has taken place. A series of 23 pools replace and incorporate the old ditch system. The design of the bunds has enabled the pools to join up and provide shallower areas as well as the deeper pools. Under the soil bunds the ground was first dug up to break any drainage pipes and prevent too much leaching. Even through the recent dry spell of about 5 or 6 weeks the levels stayed up on all but 2 of the higher pools. The bunds have also been designed so water spills out at the sides and causes a fluctuating water level. The field will I expect become a lot wetter in general.

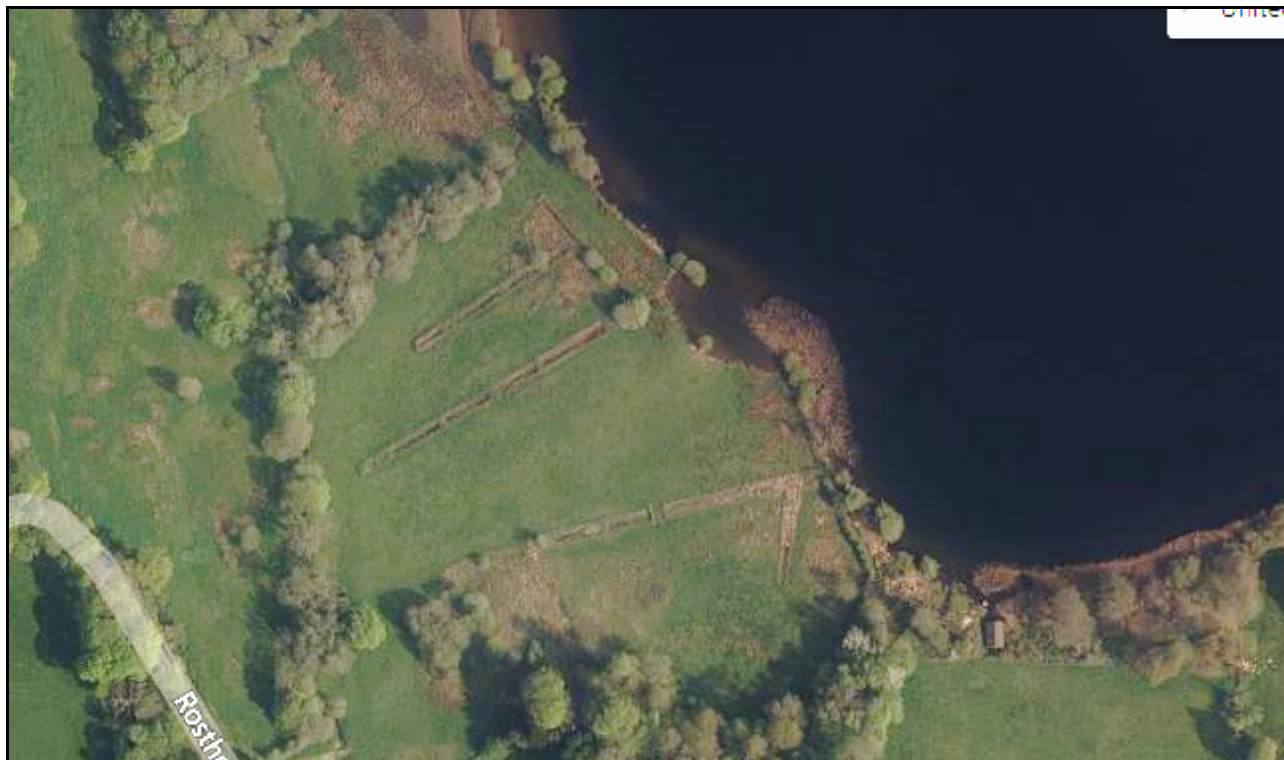
Meadow from sputnik 33, taken by андрейАбдулов, showing how Dolls Meadow looked before the recent work, most of the pools and bunds have been based on the old ditch system you can see above.Андрей, or as we say Andrei, was very impressed at the improvements. He said he would keep in touch every 3rd week ov the lunar month at 7.30pm just after Emmerdale.

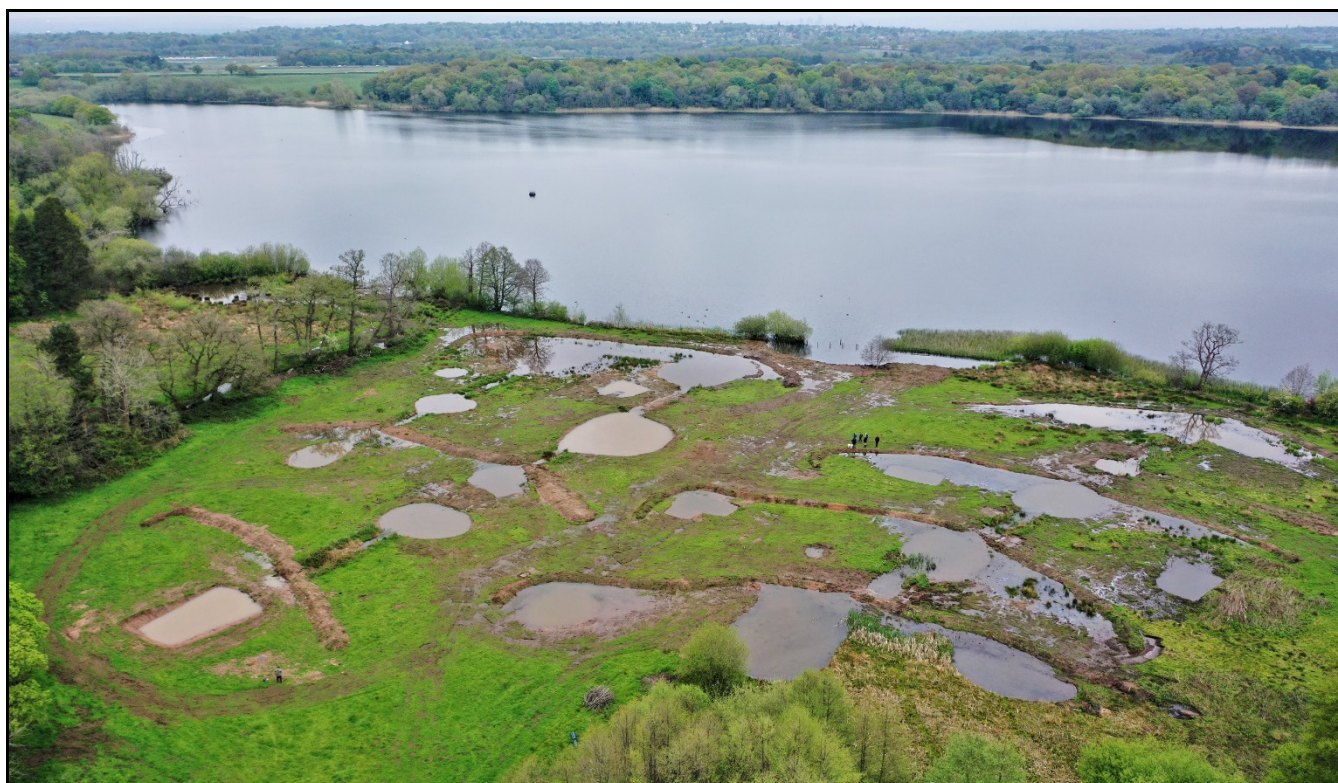
Dolls Meadow looking in a north easterly direction. This shows the bunds off a bit better and how the pools are linked by use of the bunds. Both these photos were taken on 14th May by Paul Thomas a wetland specialist and drone pilot for NE.

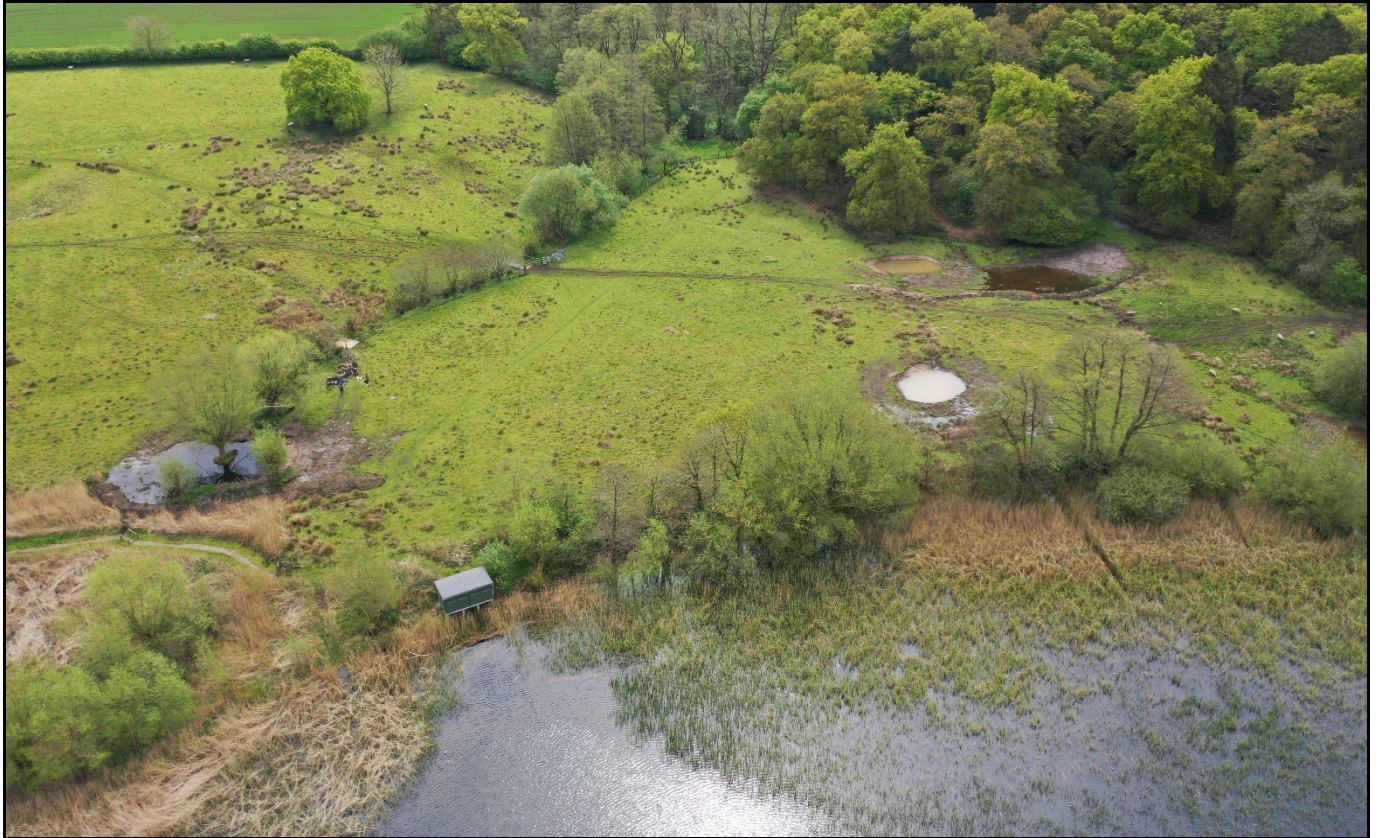
Mere Field behind the Bittern Hide looking easterly. There are five pools in the picture, but you can only just see one in the bottom right corner, there's a sixth pool left of the picture. More enhancement work is being planned this autumn and this will be an opportunity to add to and adjust some of the work in the above picture. All this work is to help strip nutrients by encouraging wetland plants and encourage deposition of silt, whilst also providing a much more diverse habitat.

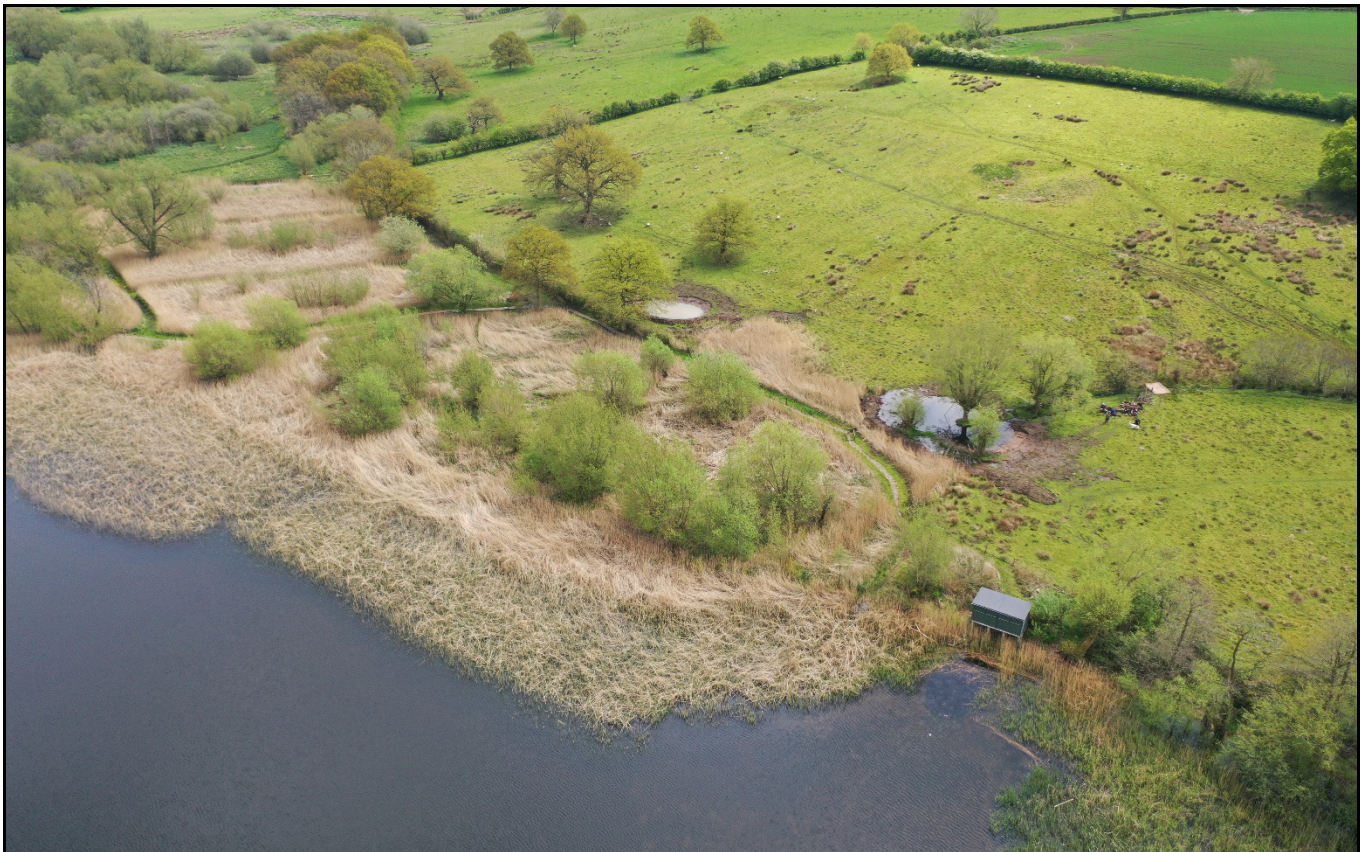
The same place but looking more north easterly including the Bittern Hide and the pool not shown in the previous picture. Nice to see all the reedbed area here

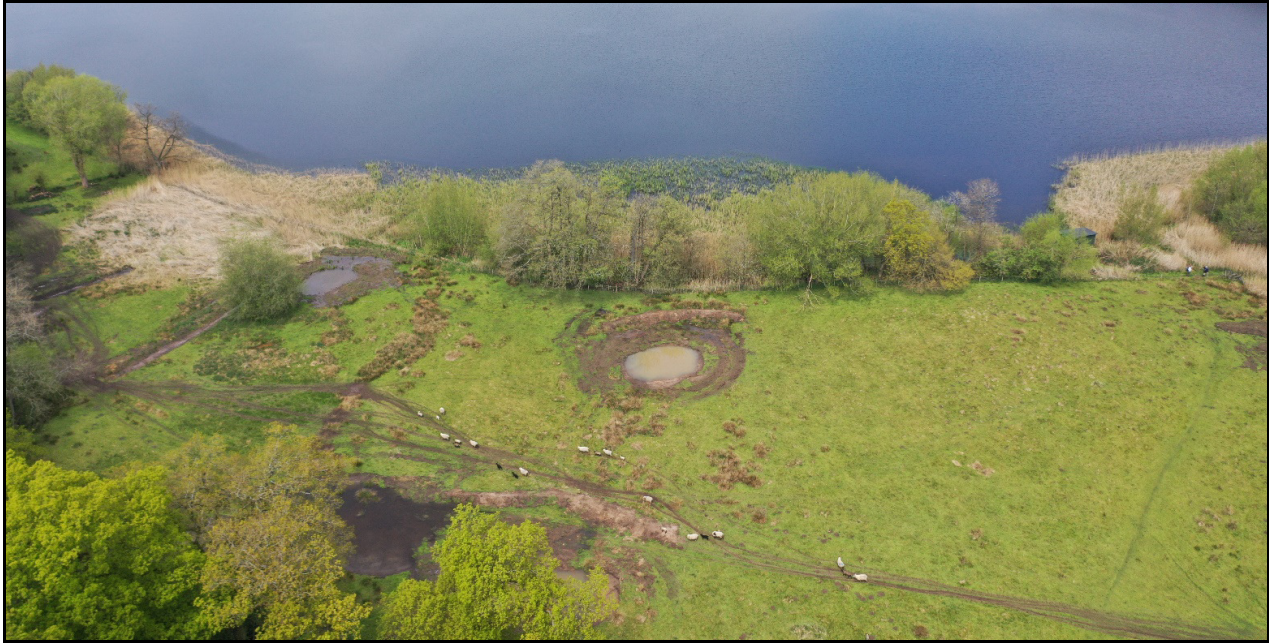
Lower Mere Field again looking westerly showing the some of the same pools.

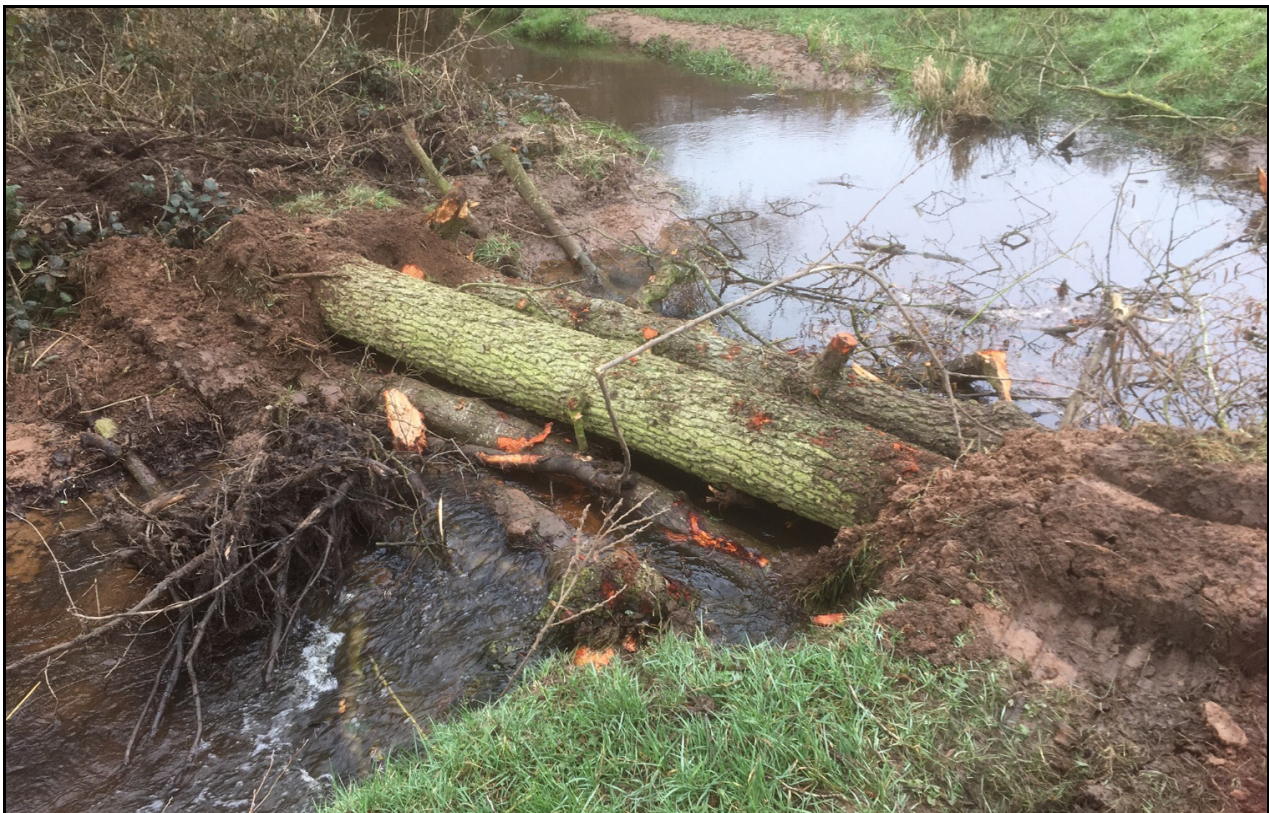
One of six leaky dams put in on the Rostherne Brook aimed at slowing the flow and encouraging flooding into the field to help deposit silt and make a more dynamic wetland. A woven willow coir where the brook meets the mere helps divert water back into the field pooling the water and sending it to filter through young willow beds.
